# Power saver

## *Leakage current properties of modern electrolytic capacitors*

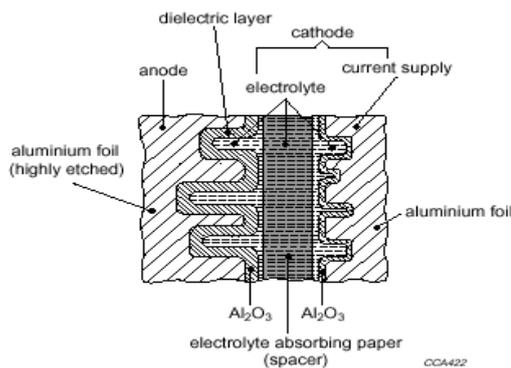
Figure 1

Principle structure of an aluminium electrolytic capacitor with non-solid (wet) electrolyte. The oxide layer on the anode forms the dielectric of the capacitor. The liquid electrolyte acts as a cathode on this large area contacting of the roughened structures of the aluminium foils.

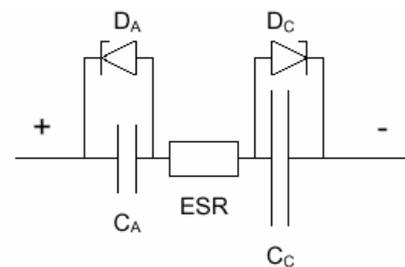
Figure 2

Equivalent circuit diagram for the leakage current properties of an aluminium electrolytic capacitor

The leakage current of an electrolytic capacitor can best be compared to the barrier current of a Zener diode, which is connected in parallel to an ideal capacitor. Because of the structure of the electrolytic capacitor this actually means that there are two diodes, one parallel to the anode capacity and the second parallel to the cathode capacity, which form the equivalent circuit diagram of the electrolytic capacitor in terms of its leakage current. However, this equivalent circuit diagram does not show the cross currents outside the electrolytic capacitor winding. As a result of this it is only an ideal diagram of the leakage current through the oxide layers in the electrolytic capacitor.

permanent low value, which now corresponds to the situation in the equivalent circuit diagram in Fig. 2.

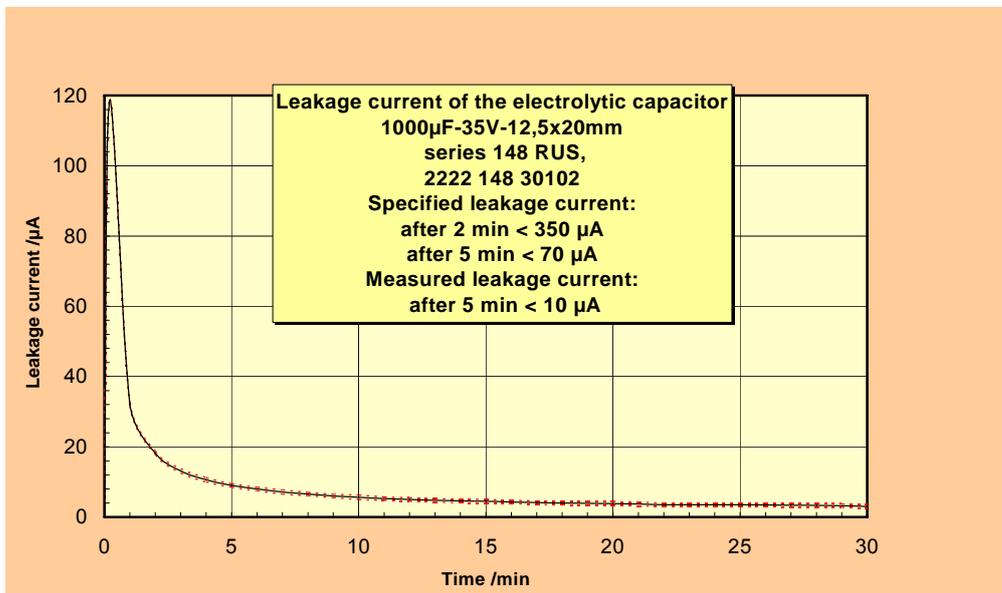
Figure 3  
 Typical time behavior of the leakage current of an aluminium electrolytic capacitor after switching on

As the curve in Figure 3 shows, the leakage current after 5 minutes in this example is by far lower than the 5-minute acceptance limit value of 70  $\mu\text{A}$ . And in this example the measured leakage current value approaches a constant, small value of around 5 to 10  $\mu\text{A}$  on an asymptotic basis. This final value is known as the **operating leakage current** and has usually established itself after around one hour. After this time all the weaknesses in the dielectric of the electrolytic capacitor of the modern professional electrolytic capacitor supplied today have been healed and the leakage current has declined to a

The leakage current value after 2 or 5 minutes, the so-called acceptance value, is relatively high compared to the curve shown in figure 3. It is specified at such a high level because normally various influences of the “previous history”, such as lengthy storage with no voltage, have a major effect on the measurement when the capacitor is switched on for the first time.

The time dependence of the leakage current is shown very clearly in the curve in Figure 3. This behaviour results from the self-healing effect of the electrolytic capacitor and the anodic oxidation or forming of the dielectric. After all, weaknesses in the dielectric, which can be created by chemical processes on the oxide layer during storage or as a result of mechanical damage during the production of the device, are healed when a voltage is applied to it. However, time is required for this healing process, also known as the forming process. The weakening of the dielectric, however, is also a question of the previous history of the capacitor. The following example is suitable to explain the term “previous history” in some more detail.

A leakage current value of around 10  $\mu\text{A}$  for a 1000  $\mu\text{F}$  electrolytic capacitor at 35 V (see Figure 3) is therefore by no means uncommon. However, this

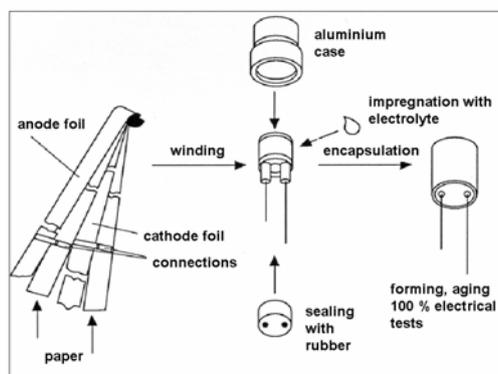
Figure 4 Principle production process of aluminium electrolytic capacitors with non-solid electrolyte

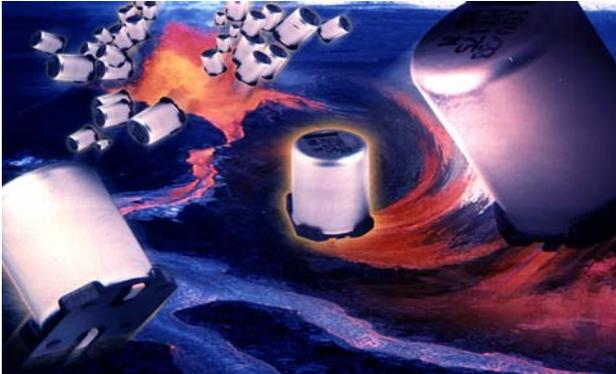
Figure 5  
Series 140 CLZ SMD electrolytic capacitors from BCcomponents are designed for applications with temperatures up to 125 °C

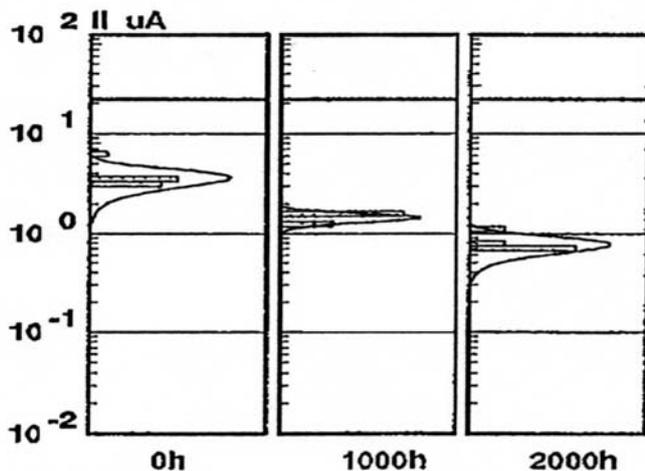
Figure 6  
Leakage current properties of electrolytic capacitors during a 2000 hours life test  
The longer the voltage is applied to the capacitor, the lower the leakage current becomes

Emotionally, the leakage current of an electrolytic capacitor is generally considered to be at a much higher level. This is due to the fact that the 5 minute value for the leakage current specified in data sheets is generally several factors higher than the actual operating leakage current. And the operating leakage current will not be reached, of course, until the capacitor has been operating for a certain length of time, until in fact the weaknesses in the dielectric have been healed properly. And the longer the voltage is applied to the capacitor, the lower the leakage current will be – see Figure 6.

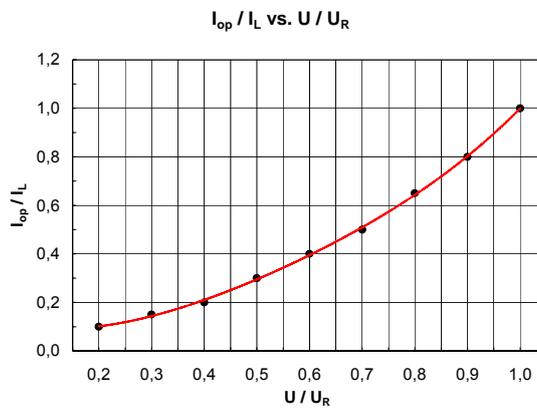
Figure 7

Typical multiplier of the operating leakage current as a function of the voltage applied

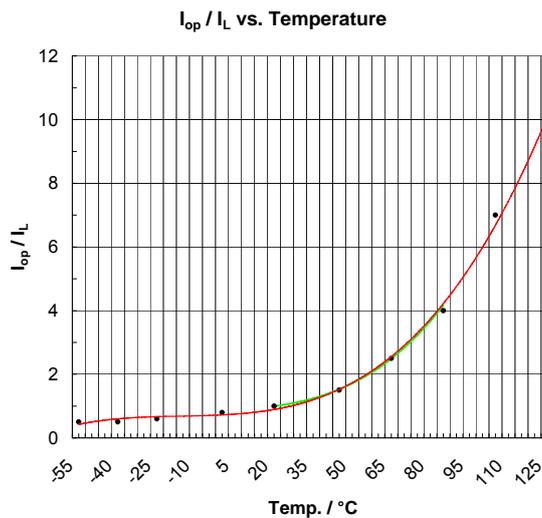
Figure 8

Typical multiplier of the operating leakage current as a function of the capacitor temperature

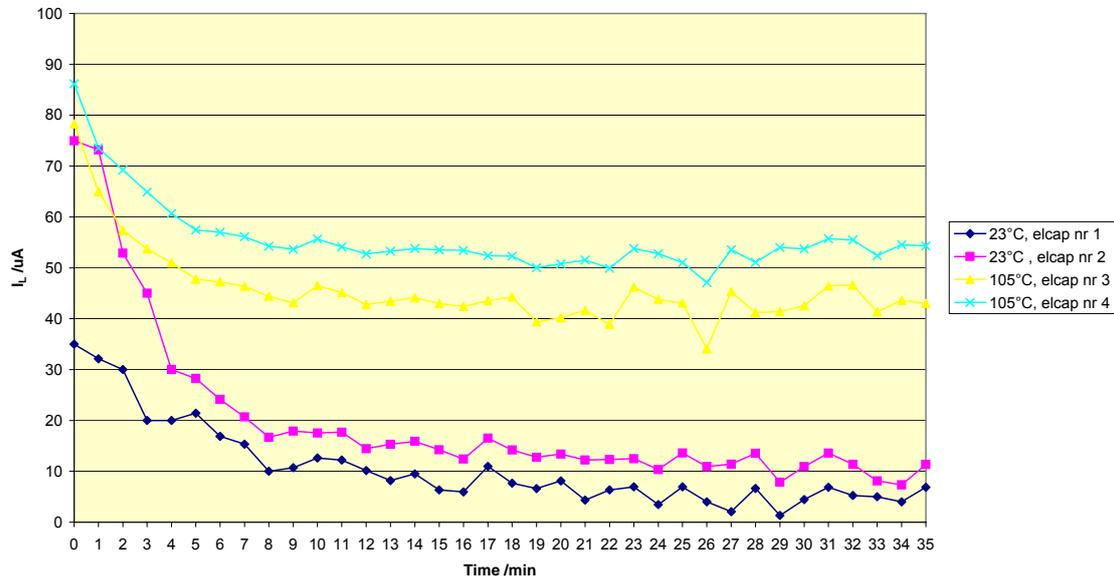
Figure 9

Leakage current, Type 2100  $\mu\text{F}/63\text{ V}$  25 x 40 mm, Series 058 PLL-SI, 2222 058 90019  
measurement at 23°C and 105°C

Temperature dependence of the operating leakage current of a 2100  $\mu\text{F}/63\text{ V}$  electrolytic capacitor at 23°C and 105°C

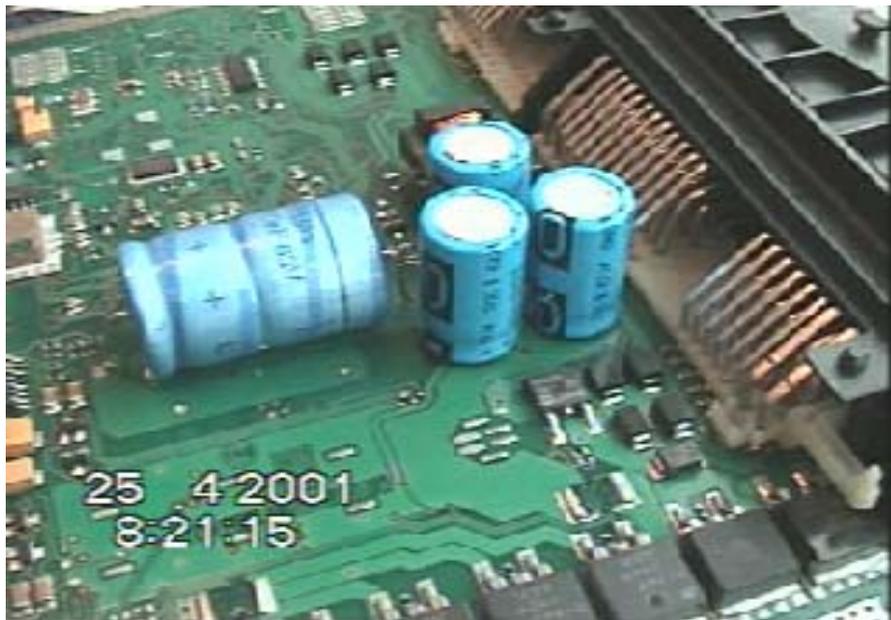
Figure 10  
Electrolytic capacitors in a motor vehicle injection circuit from Bosch

In another former motor vehicle application, however, high efforts have been made to achieve very good leakage current properties from the very beginning. The former flashers in a car were activated using timing elements (RC elements). If the leakage current increases too much, the flasher frequency changes. The motor vehicle approval authorities were very strict in this respect. The flashing frequencies had to be within precisely defined limits. The discussion about timing elements using a resistor and an electrolytic capacitor also resulted in the rule of thumb for the function of a circuit of this type – the current defined by the series resistor should be 10 times as high as the 5 minute value for the leakage current of the electrolytic capacitor.

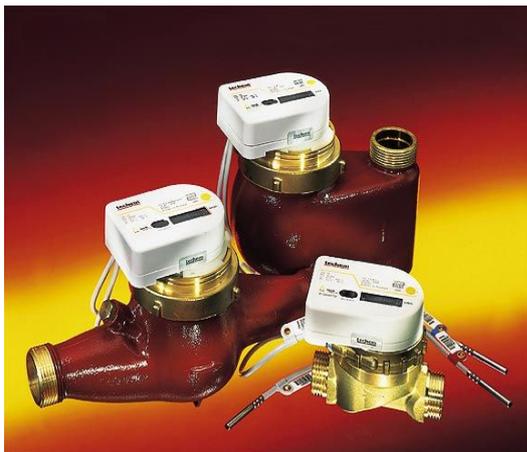
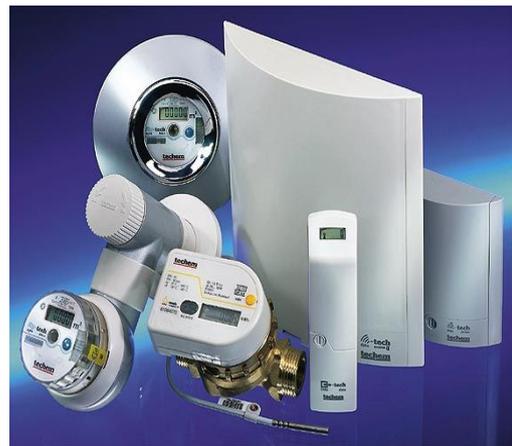
Figures 11 and 12  
Heat metering devices, Techem

The heat meter circuit is powered by a lithium battery which supplies the circuit with energy for a period of 10 years without requiring any maintenance.

Extremely high demands on very low leakage current values are very common in an application that affects many households. This application is heating cost readers installed on heating equipment to transmit the temperatures of the radiators to a central computer by means of pulse coding. The reading circuit has no mains connection. The energy for the transmitted pulses for a useful or service life of 10 years is stored in a battery. A buffer electrolytic capacitor provides the low resistivity supply of the transmission energy for the radio signals required in this circuit. This means that the electrolytic capacitor leakage current influences the overall useful life of the reading circuit. It is noticeable that the manufacturers strive hard to reduce the leakage current of the electrolytic capacitor by every possible  $\mu\text{A}$ . The factor that makes this even more difficult is that the circuit on the radiator becomes hot and the leakage current increases with the temperature.

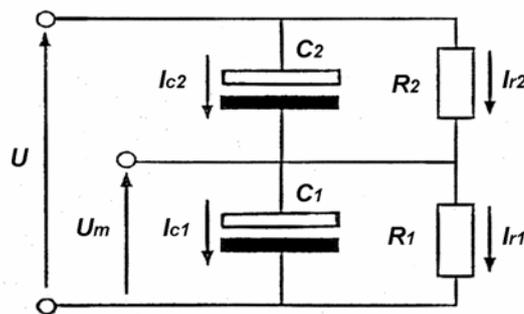
Figure 13

Electrolytic capacitors connected in series have to be balanced by using external balancing resistors  $R_1$ ,  $R_2$  in order to avoid voltage differences based on different leakage currents  $I_{c1}$  and  $I_{c2}$ .

This leakage current difference is normally kept under control by using balancing (Figure 13,  $R_1$ ,  $R_2$ ) resistors over each of the individual components. The method to calculate the symmetry resistors is set out in the "Guideline for the use of aluminium electrolytic capacitors, DIN 45811".

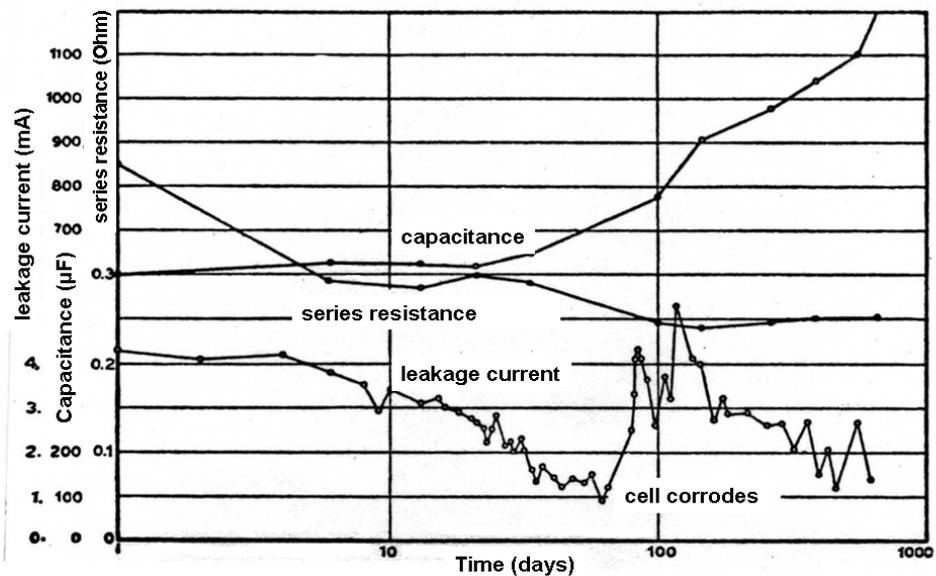
Figure 14  
Curves showing the capacitance, the series resistance and the leakage current in an 1000 hours endurance test on a 700 µF/65 V electrolytic capacitor dating from 1929  
Peculiarity: Corrosion and its influence on the leakage current

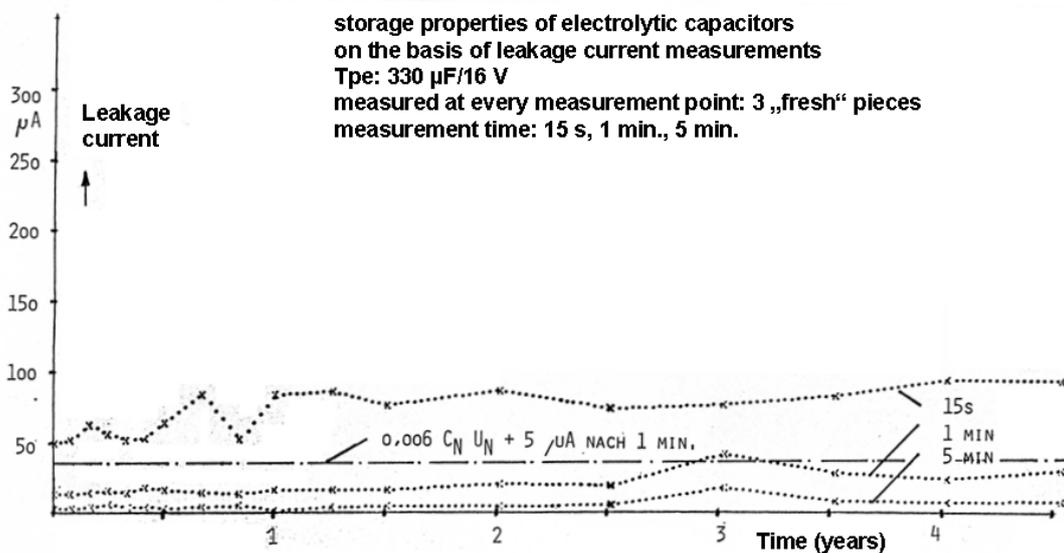
Figure 15  
Testing the storage properties of electrolytic capacitors on the basis of leakage current measurements on 3 “fresh” capacitors after the specified storage period  
Even after 4 years, no increased leakage current values were found on these electrolytic capacitors from BCC

However, for the well-informed developer there is a relationship, a test, which, whilst it does not indicate particularly low leakage current values, nevertheless shows that the electrolytic capacitor will offer good long term stability. This is the hot storage test. This relates to a test which is conducted at the upper category temperature without any voltage being applied. No voltage means that no self-healing can take place. And since the test is conducted at high temperature, all the chemical dissolution processes will be accelerated greatly. The international standard IEC 60384-4 defines a minimum test time of 100 hours. A hot storage test time of 500 or 1000 hours therefore means that the manufacturer is sure that the electrolyte is essentially chemically inert, that the oxide layer does not suffer weakness and therefore that no increased residual current will occur. The lack of any such specification in a data sheet or a test time of only 100 hours could therefore indicate that the electrolytic capacitor may not be very stable in terms of this parameter.
